# Safety Inspection Report

Annual Inspection

## Chichester Avenue Play Area

Site name: **Chichester Avenue Play Area**  
Date of inspection: **19 September 2024**  
Inspector: **Frank Goodwin**

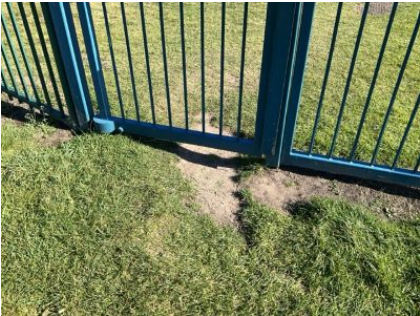
# Gate - Access

Worn ground areas.

Level of soil.

6

Make good.

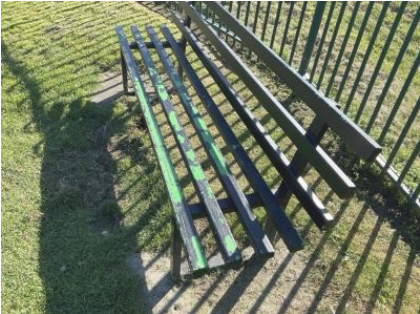
# Seating

Paintwork is in poor condition.

5

De-scale back to good base material and coat with lead free paint, using appropriate precautions. Repairs may be necessary where corrosion is severe.

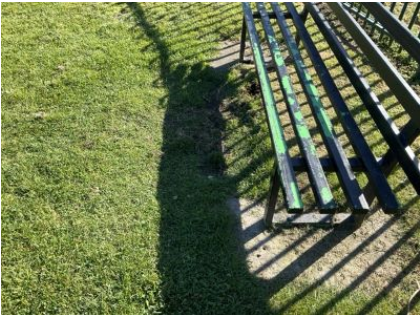
Worn ground areas.

Uneven.

5

Make good.

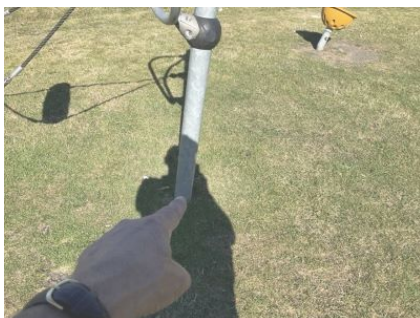
## Swing - Surfer

Loose in ground.

Reset.

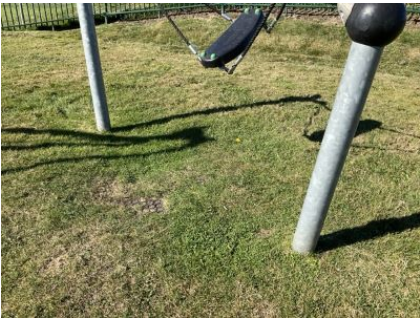
This equipment relies on one post for its stability. Special attention should be paid to maintenance (e.g. by monitoring degradation) and if necessary decommissioning the item before the end of its operating life.

6

Consult with the manufacturer's guidance to determine suitable maintenance.

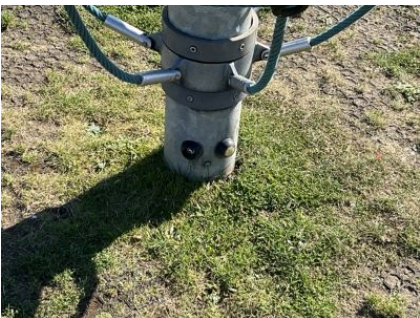
# Climber - Rota Web

Cap missing.

5

Replace.

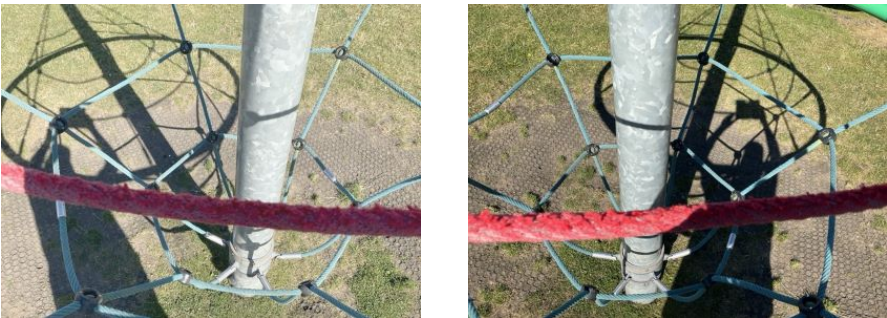
Wire is exposed.

4

No reasonably practicable action is identified.

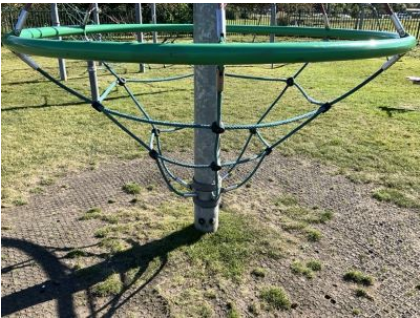
This equipment relies on one post for its stability. Special attention should be paid to maintenance (e.g. by monitoring degradation) and if necessary decommissioning the item before the end of its operating life.

6

Consult with the manufacturer's guidance to determine suitable maintenance.

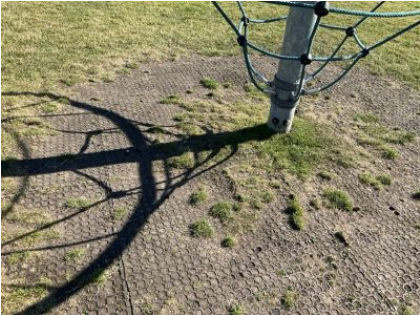
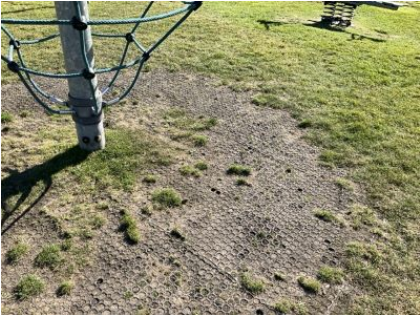
Worn ground areas.

8

Make good.

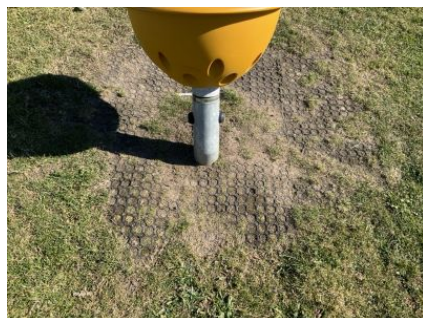
Worn ground areas.

Make good.

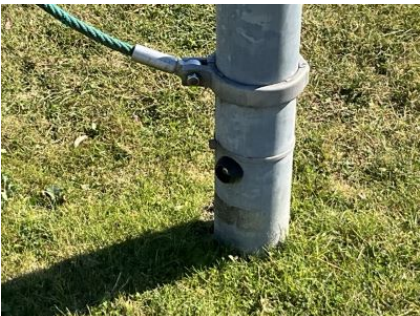
# Climber - Frame - Rope

Cap missing.

One bolt has a sharp edge.

8

Replace.

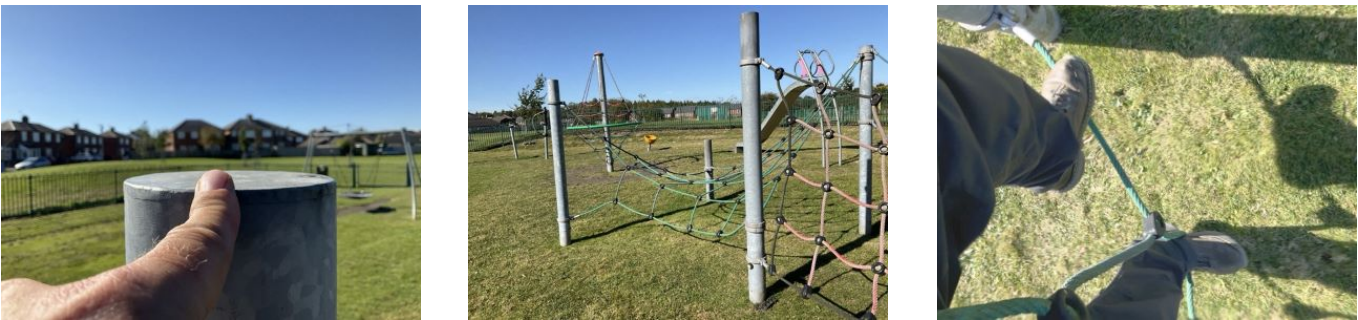
The item is not compliant with the requirements of the relevant standards. The surfacing meets with the requirements of the relevant standards.

Edges not radiused or chamfered.

8

Refer to manufacturer for comment.

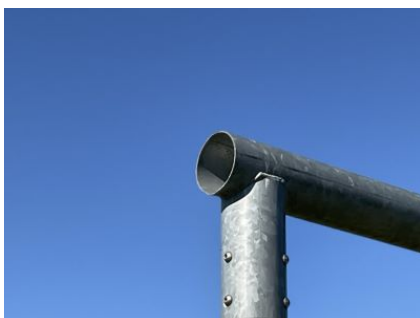
Cap missing.

At top bar.

Replace.

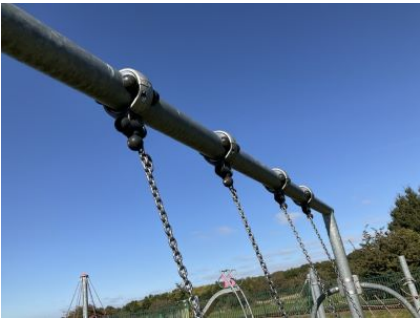
The covers should be removed from the fitting at the top of the chain annually and the shackle bolt should be checked for wear. Check the security of the fittings too.

4

Replace at 70% of original diameter (30% wear). Check the security of the fittings.

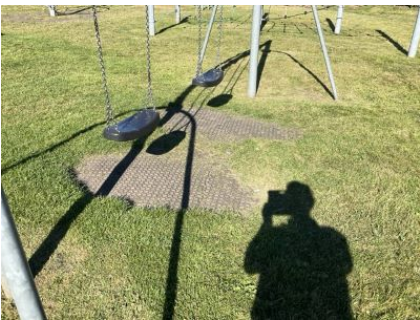
Worn ground areas.

8

Make good.

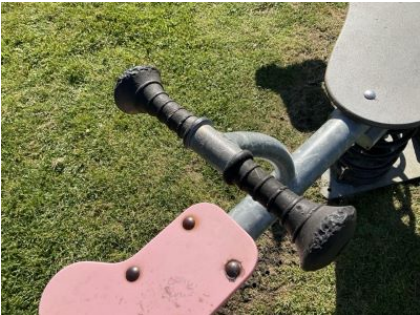
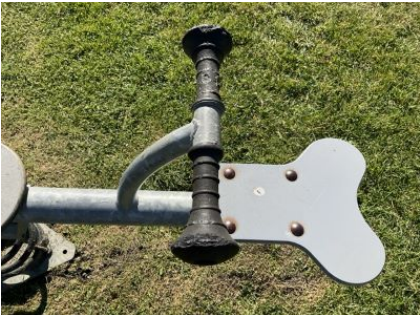
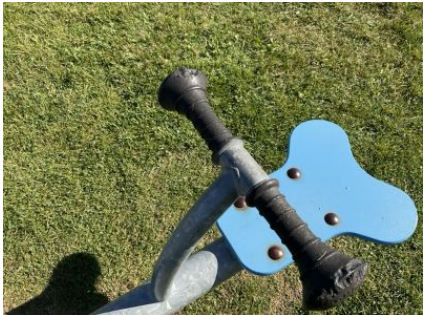
Vandalised.

Monitor.

Risk score:  
 4

Read the notes for further action.

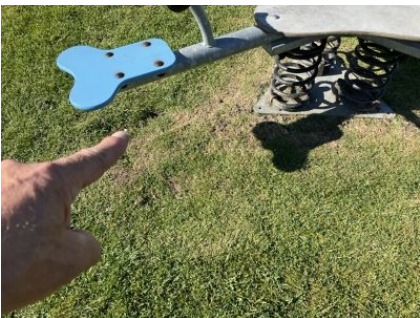
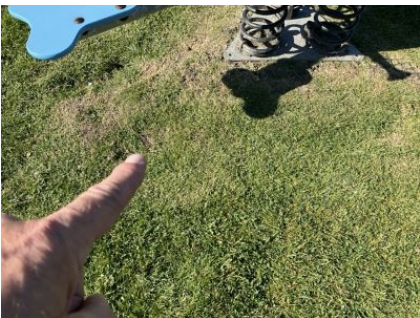
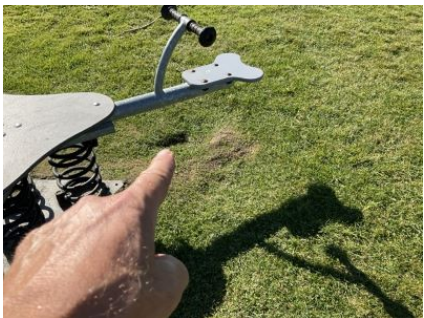
Surface is uneven.

Risk score:  
 7

Make good.

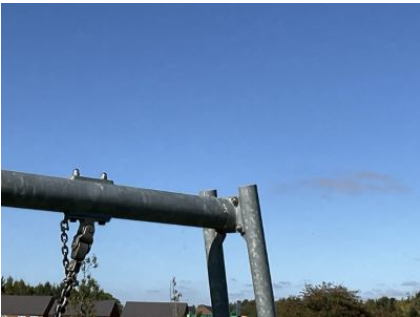
# Swing - Nest

Cap missing.

At uprights.

5

Replace.

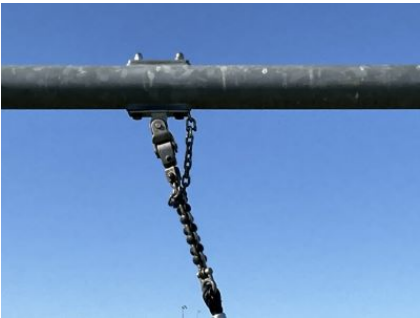
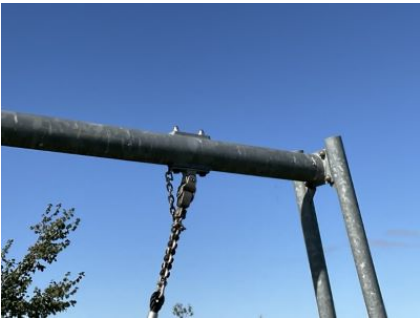
The supporting components should be dismantled and inspected according to the manufacturer's instructions. This will need doing on a regular basis, as defined by the manufacturer. This can lead to a high risk if no action is taken.

6

Dismantle and inspect according to manufacturer's instructions.

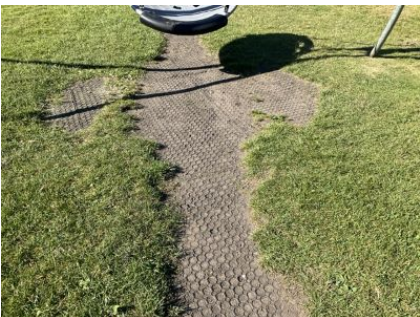
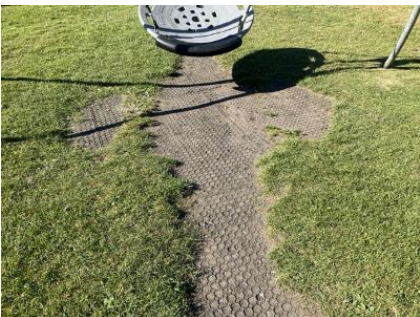
Worn ground areas.

8

Make good.
