# Safety Inspection Report

## Sevenoaks Park Play

Cramlington Town Council

22 September 2024

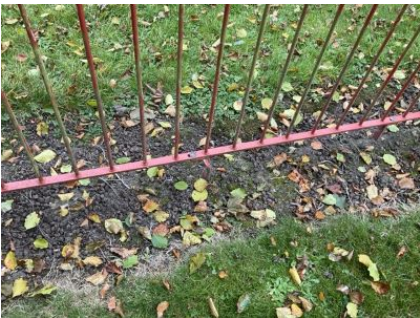
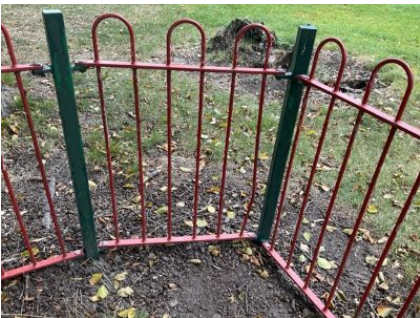
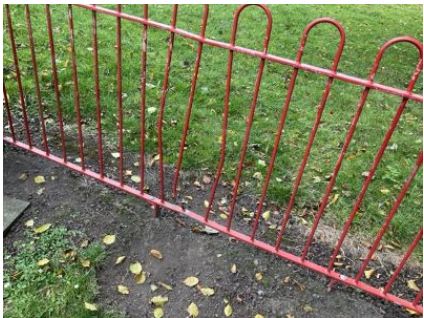
Minor repairs are needed.

Repair.

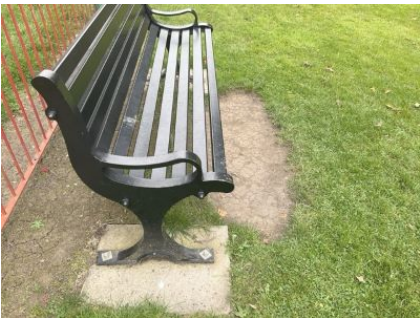
Worn ground areas.

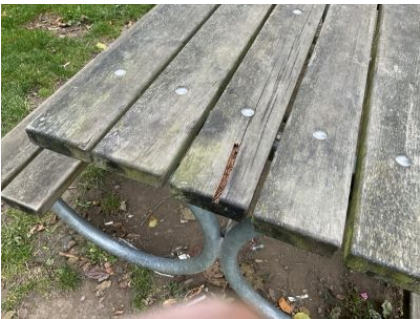
There is decay to timber components which may affect structural integrity. We do not recommend replacing rotten supports with timber posts which are directly set in the ground due to the increased problem of timber rot, especially in posts in contact with the ground.

Replace decayed components where possible and plan replacement of item.  
Check on a routine basis, especially at ground or foundation level.

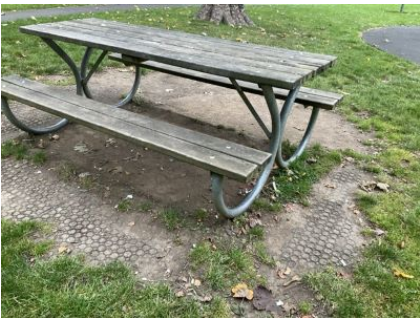
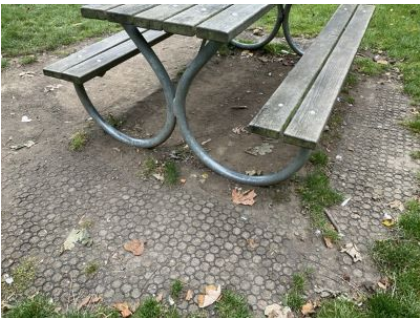
Worn ground areas.

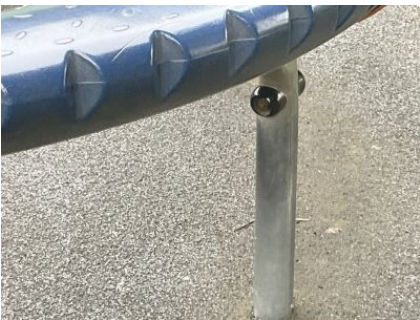
Cap missing.

Replace.

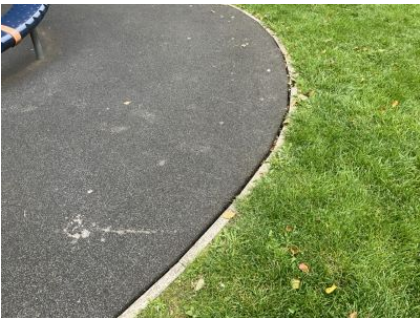
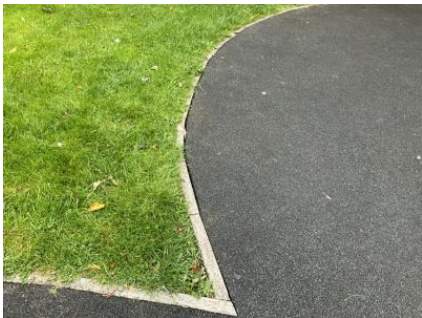
Shrinkage / separation of the surface. This may give a trip hazard.

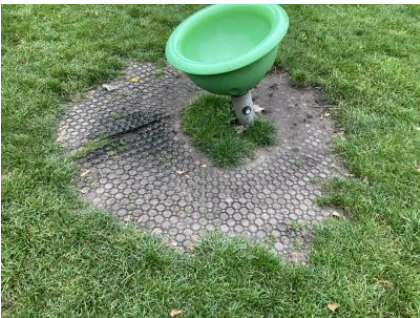
Worn ground areas.

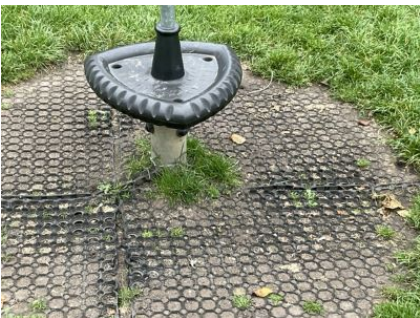
This equipment relies on one post for its stability. Special attention should be paid to maintenance (e.g. by monitoring degradation) and if necessary decommissioning the item before the end of its operating life.

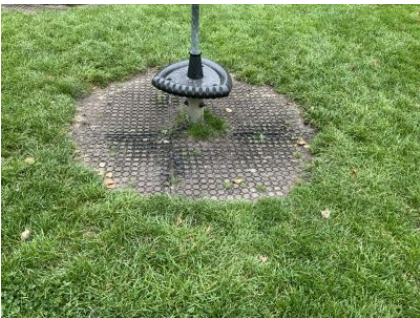
Worn ground areas.

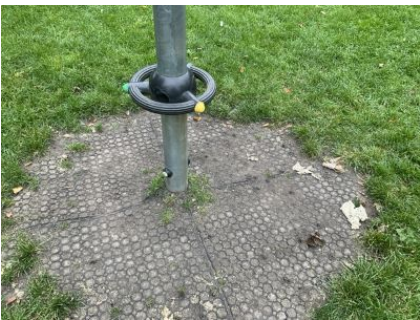
This equipment relies on one post for its stability. Special attention should be paid to maintenance (e.g. by monitoring degradation) and if necessary decommissioning the item before the end of its operating life.

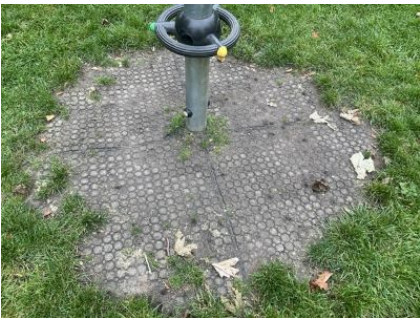
Worn ground areas.

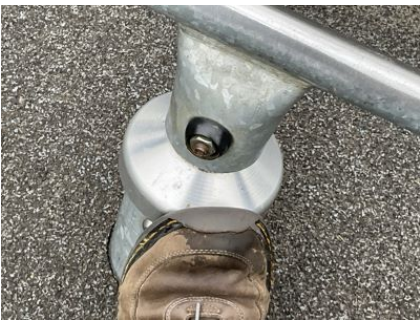
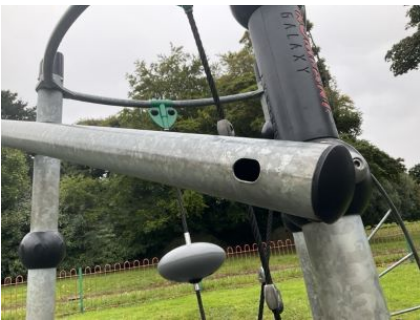
Cap missing.

Replace.

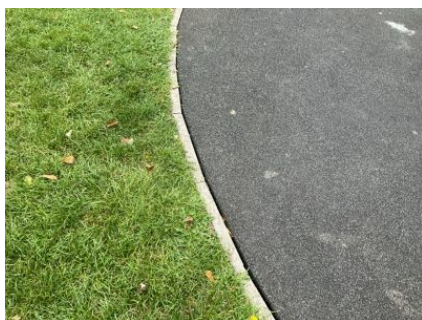
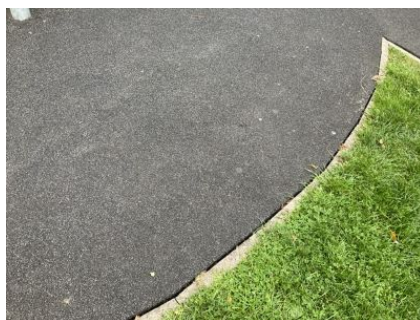
Shrinkage / separation of the surface. This may give a trip hazard.

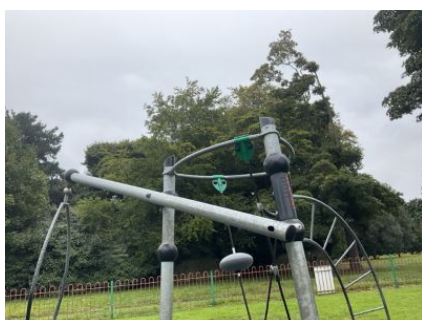
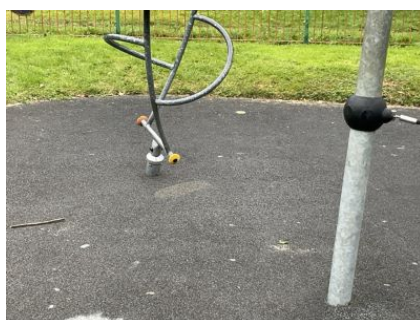
This equipment relies on one post for its stability. Special attention should be paid to maintenance (e.g. by monitoring degradation) and if necessary decommissioning the item before the end of its operating life.

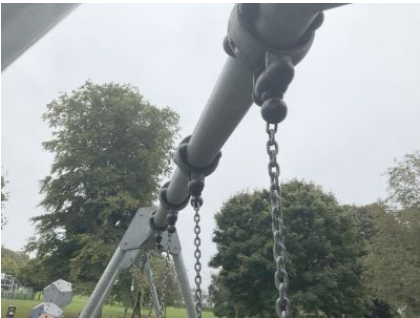
The covers should be removed from the fitting at the top of the chain annually and the shackle bolt should be checked for wear. Check the security of the fittings too.

Replace at 70% of original diameter (30% wear). Check the security of the fittings.

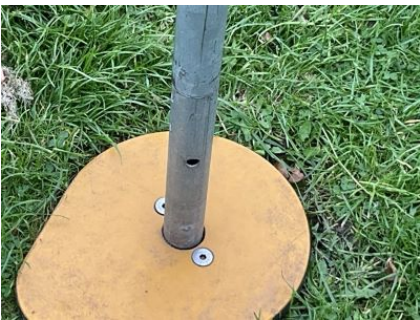
Cap missing.

Replace.

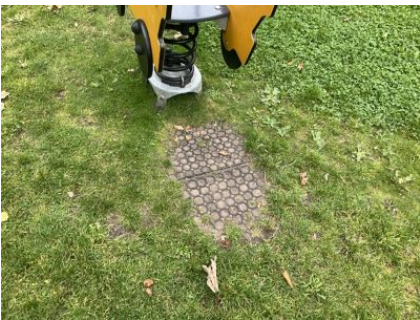
Worn ground areas.

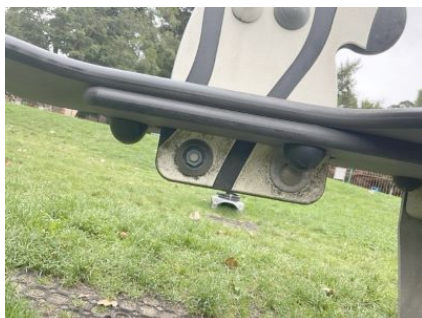
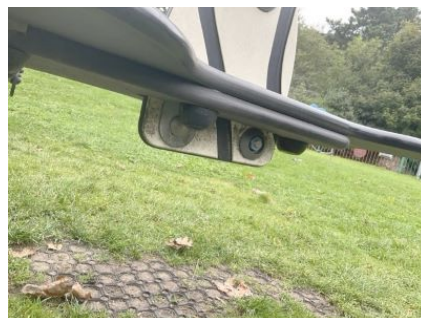
Cap missing.

Replace.

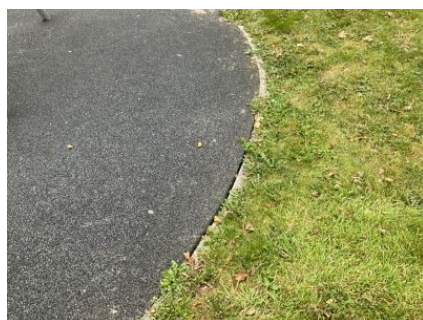
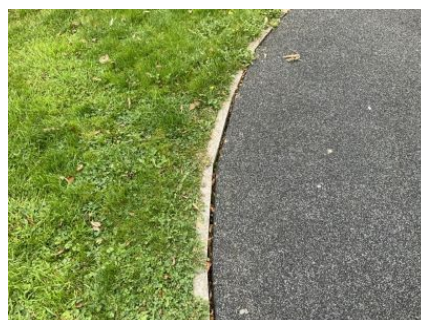
Shrinkage / separation of the surface. This may give a trip hazard.

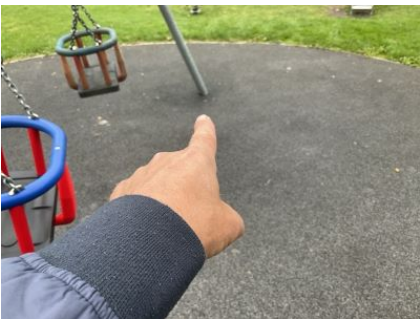
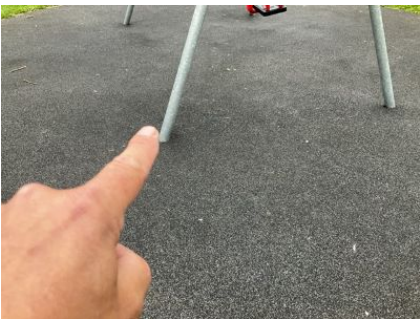
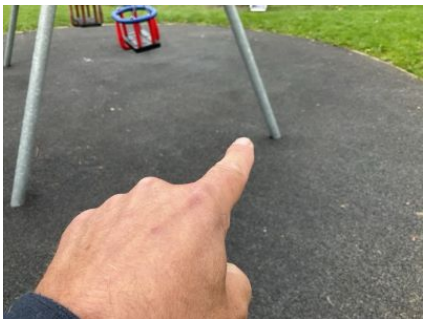
The covers should be removed from the fitting at the top of the chain annually and the shackle bolt should be checked for wear. Check the security of the fittings too.

At foundations.

Replace at 70% of original diameter (30% wear). Check the security of the fittings.
