# Safety Inspection Report

Annual Inspection

## Chichester Avenue Play Area

Site name: **Chichester Avenue Play Area**  
Date of inspection: **19 September 2024**  
Inspector: **Frank Goodwin**

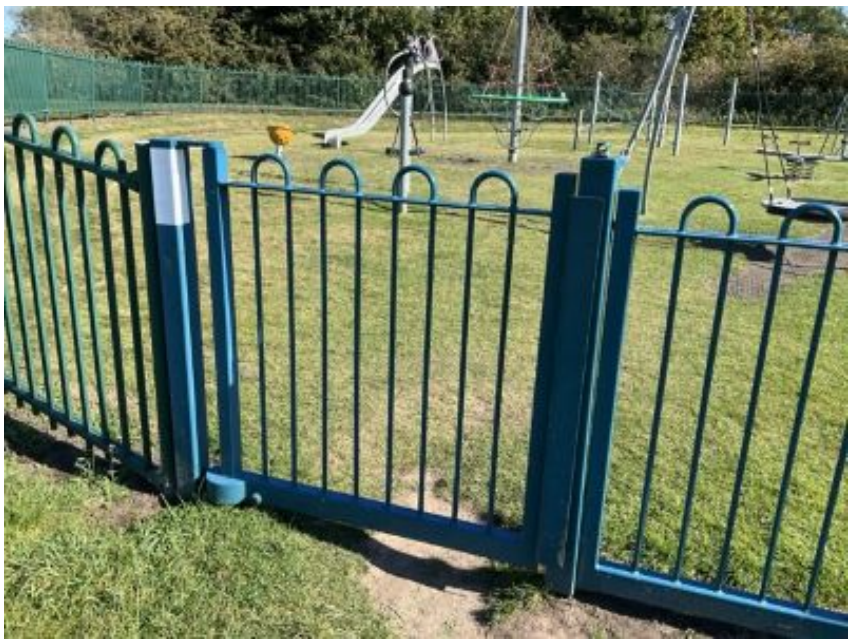
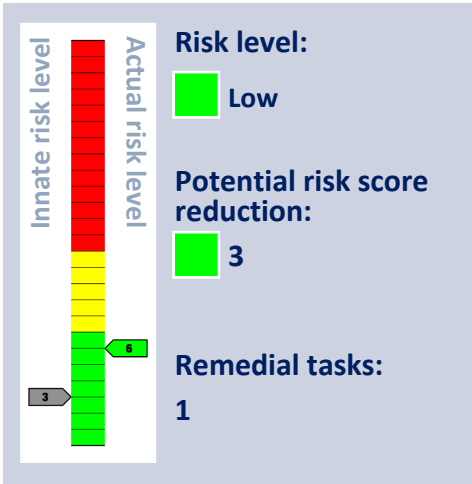
# Gate - Access

Worn ground areas.

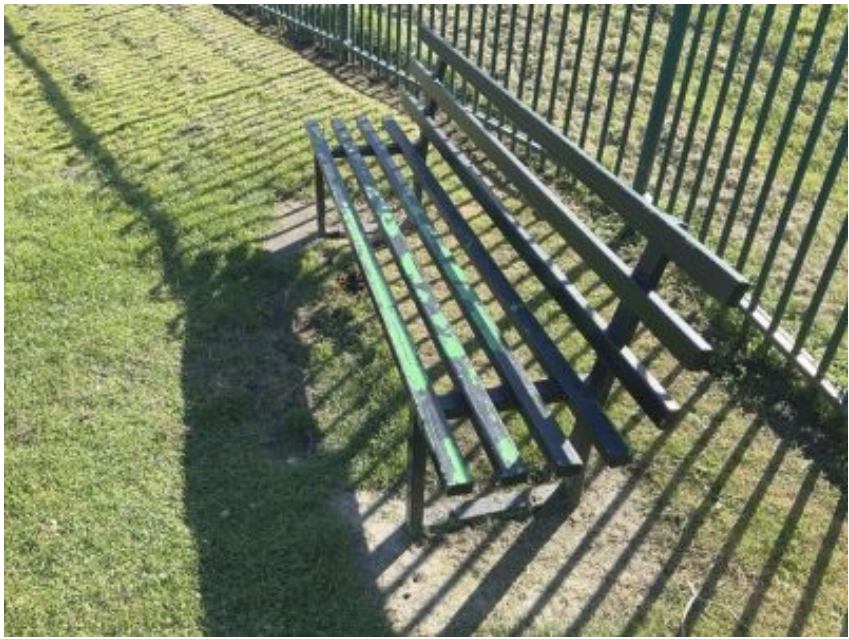
# Seating

Paintwork is in poor condition.

Worn ground areas.

De-scale back to good base material and coat with lead free paint, using appropriate precautions. Repairs may be necessary where corrosion is severe.

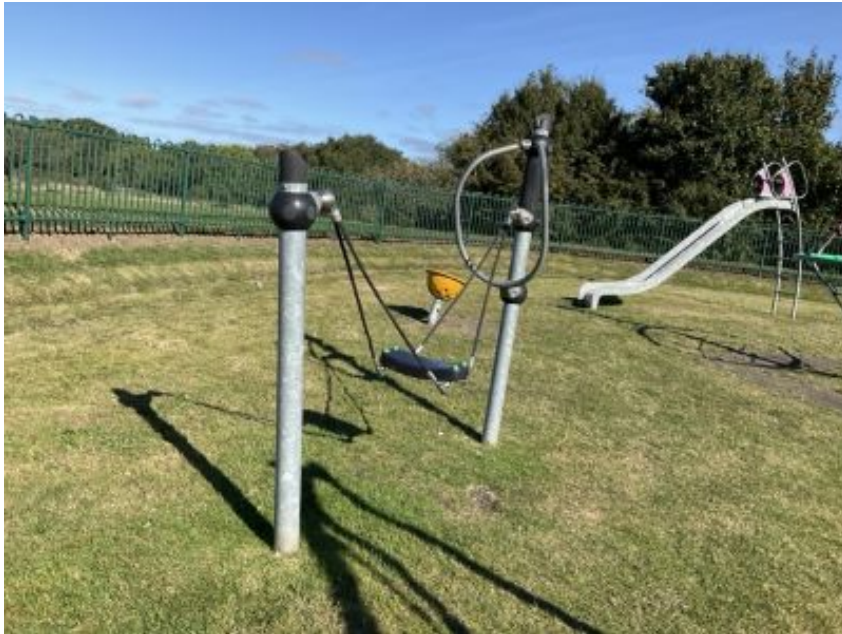
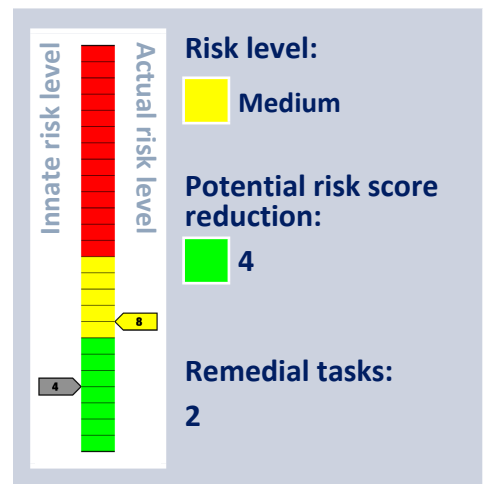
## Swing - Surfer

Loose in ground.

This equipment relies on one post for its stability. Special attention should be paid to maintenance (e.g. by monitoring degradation) and if necessary decommissioning the item before the end of its operating life.

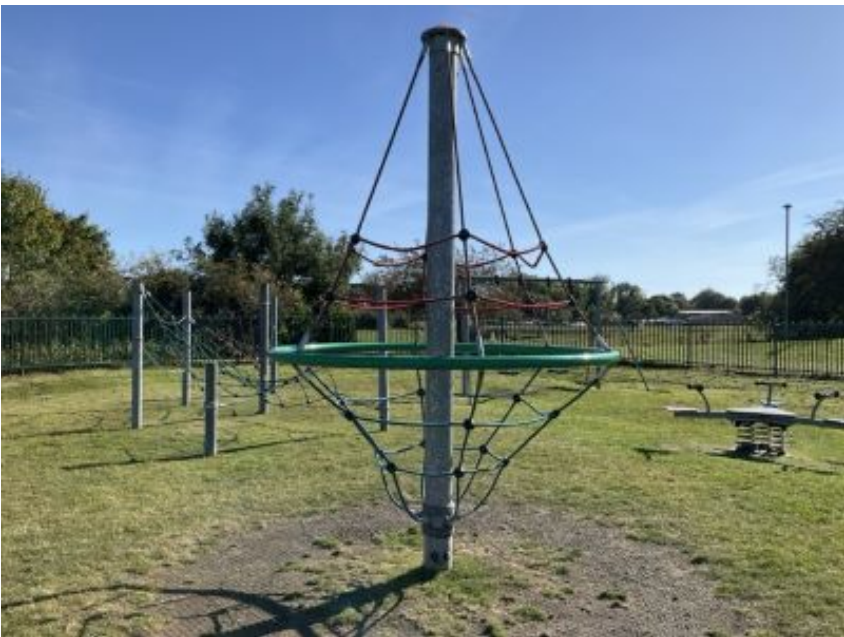
# Climber - Rota Web

Cap missing.

This equipment relies on one post for its stability. Special attention should be paid to maintenance (e.g. by monitoring degradation) and if necessary decommissioning the item before the end of its operating life.

Worn ground areas.

Replace.

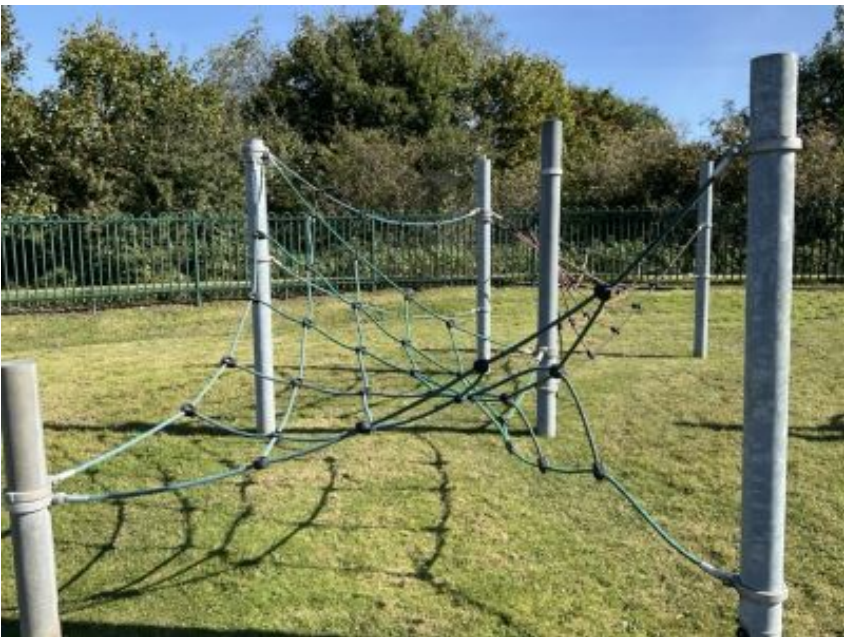
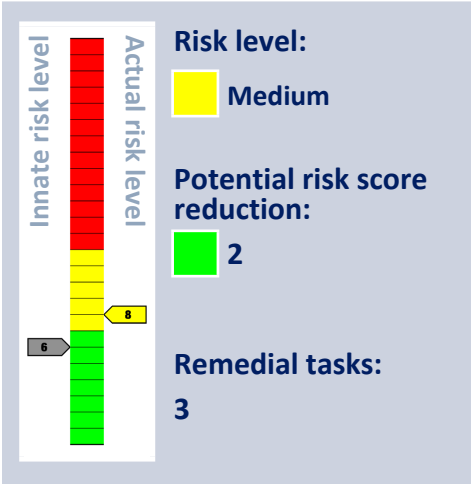
# Climber - Frame - Rope

Cap missing.

This equipment relies on one post for its stability. Special attention should be paid to maintenance (e.g. by monitoring degradation) and if necessary decommissioning the item before the end of its operating life.

Replace.

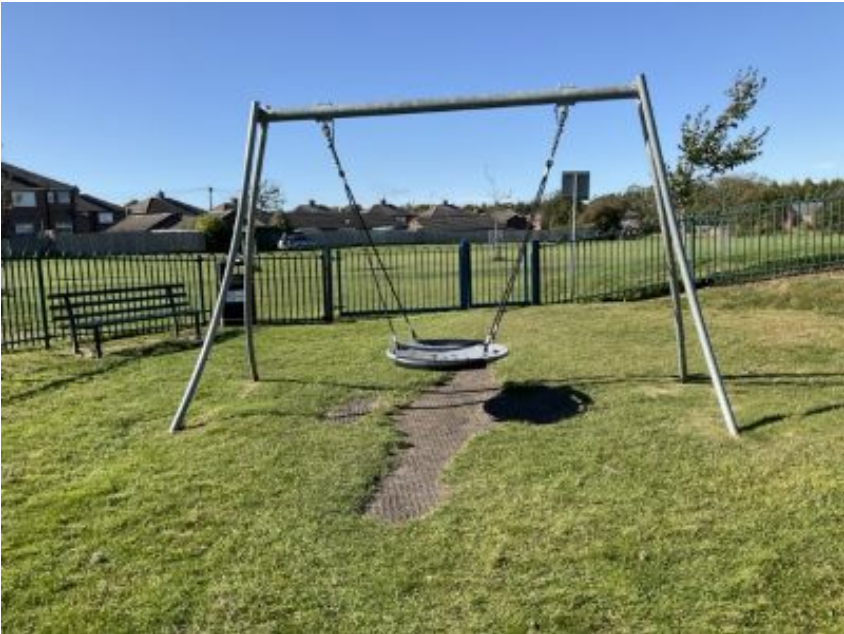
# Swing - Nest

Cap missing.

Worn ground areas.

Replace.
