# Safety Inspection Report

Annual Inspection

## Eastfield Park Outdoor Gym

Cramlington Town Council

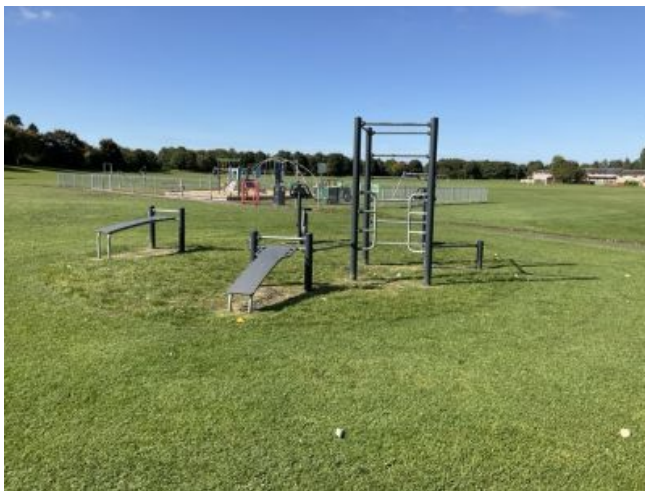
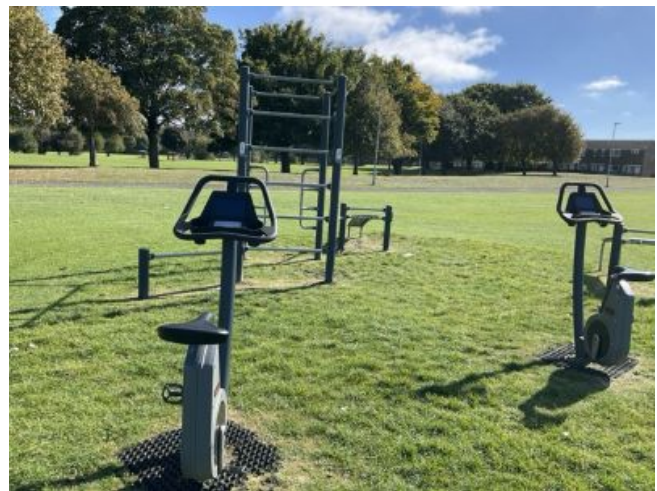
Well used facility.  
Well maintained.

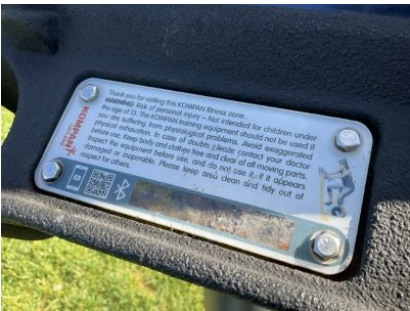
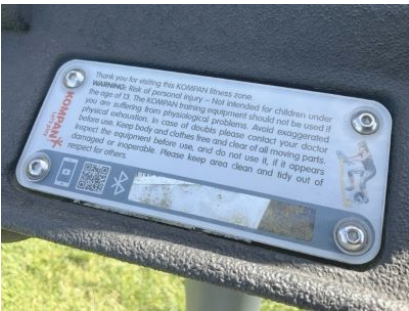
# Signage

Additional comments are noted below.

Monitor.

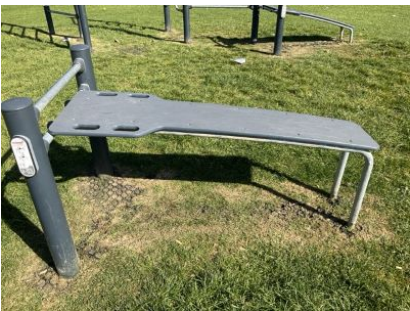
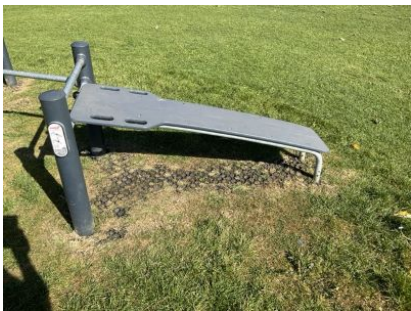
# Adult Fitness - Abs Bench

The item and its surfacing (where applicable) meet with the requirements of the relevant standards.

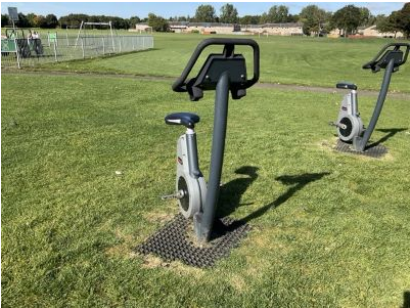
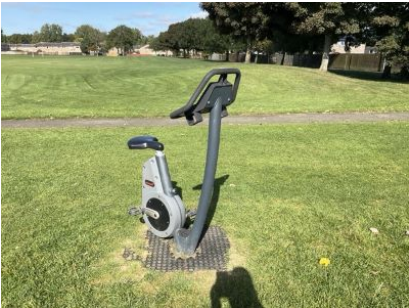
# Fitness - Bikes x 2

EN 16630:2015  
The item and its surfacing (where applicable) meet with the requirements of the relevant standards.

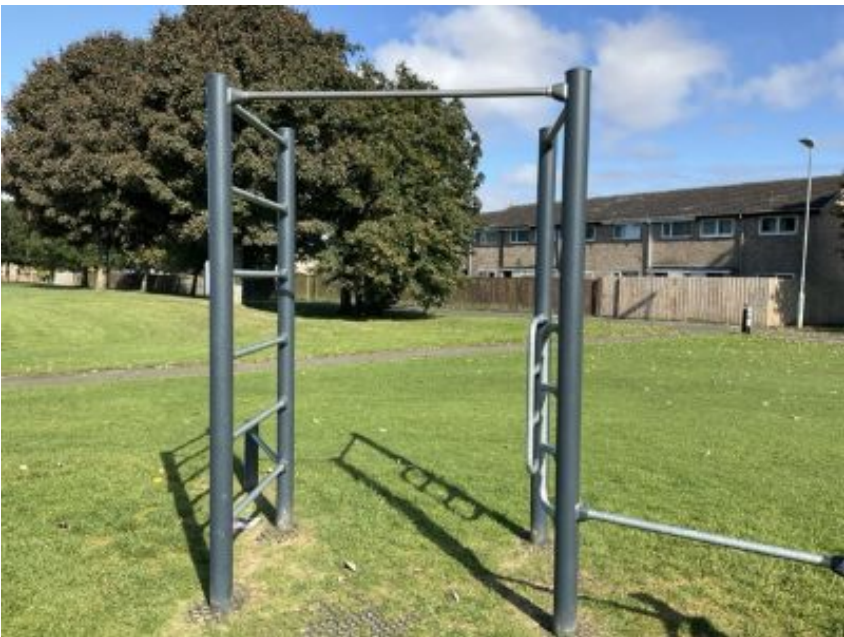
# Adult Fitness - Combination Unit

EN 16630:2015  
The item and its surfacing (where applicable) meet with the requirements of the relevant standards.
