# Safety Inspection Report

Annual Inspection

## Horton Park Play Area

Cramlington Town Council

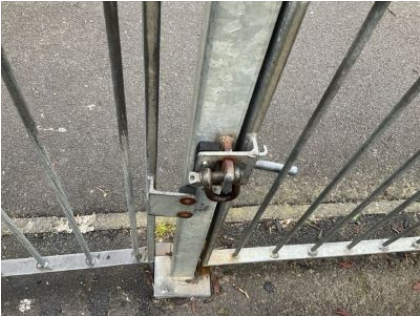
# Gate - Maintenance

Butterfly shackles have been used, presenting non-rounded edges.

It is recommended that an alternative type of shackle that does not have sharp ends be used. Use fixings compliant with EN 1176.

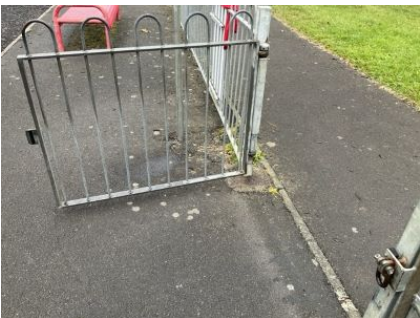
# Gate

The gate's closing mechanism does not work correctly.

Adjust to allow gate to self close. Ideally gate from open should not close in less than 5 seconds.

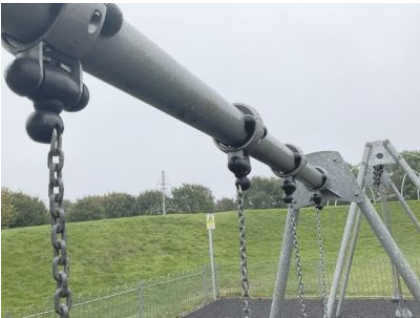
# Swing - Toddler - 1 Bay 2 Seat

The covers should be removed from the fitting at the top of the chain annually and the shackle bolt should be checked for wear. Check the security of the fittings too.

Replace at 70% of original diameter (30% wear).

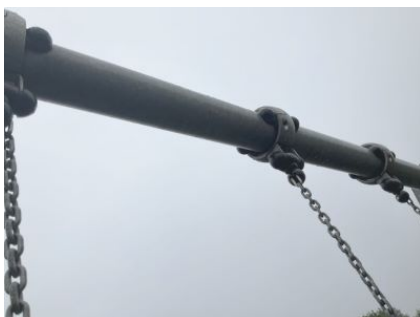
## Swing - Junior - 1 Bay 2 Seat

The covers should be removed from the fitting at the top of the chain annually and the shackle bolt should be checked for wear. Check the security of the fittings too.

Replace at 70% of original diameter (30% wear). Check the security of the fittings.

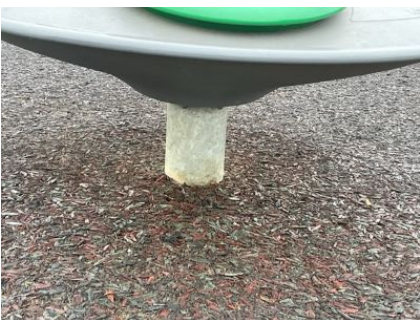
# Carousel - Bucket Seats

This equipment relies on one post for its stability. Special attention should be paid to maintenance (e.g. by monitoring degradation) and if necessary decommissioning the item before the end of its operating life.

Consult with the manufacturer's guidance to determine suitable maintenance.

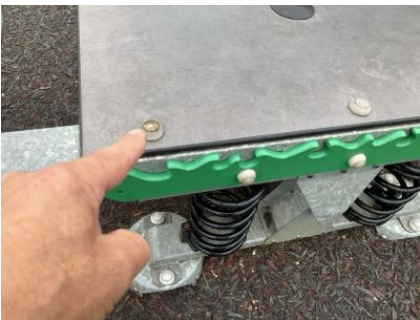
# Rocker - Seesaw - Multi-Spring

Cap missing.

Replace.

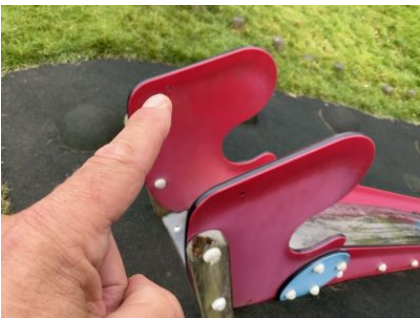
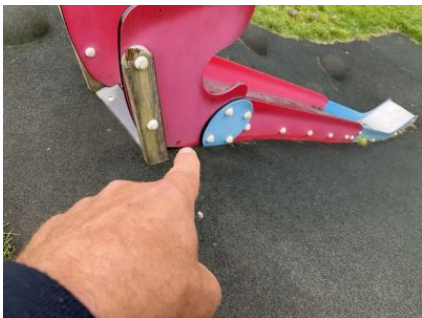
# Slide - Embankment

Cap missing.

Replace.

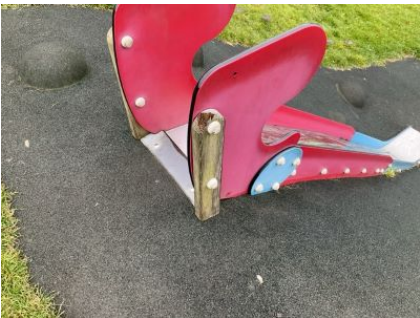
Timber is decayed.

Repair.

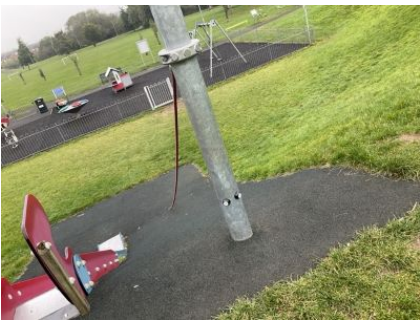
# Rope Pull

This equipment relies on one post for its stability. Special attention should be paid to maintenance (e.g. by monitoring degradation) and if necessary decommissioning the item before the end of its operating life.

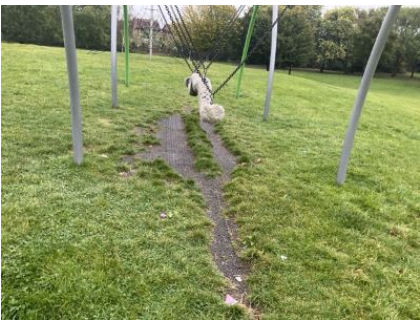
# Swing - Rope - Horizontal

Worn ground areas.

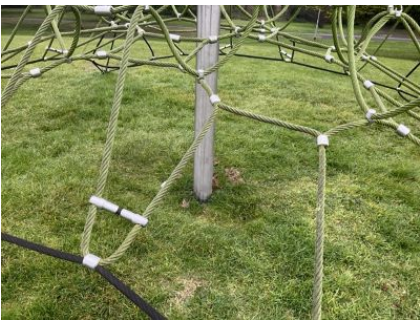
# Climber - Space Net

This equipment relies on one post for its stability. Special attention should be paid to maintenance (e.g. by monitoring degradation) and if necessary decommissioning the item before the end of its operating life.
