# Safety Inspection Report

## Sevenoaks Park Play

Cramlington Town Council

22 September 2024

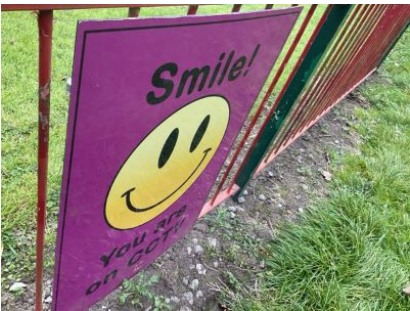
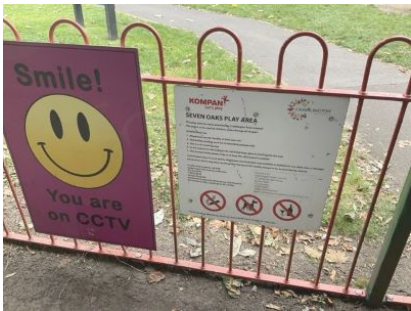
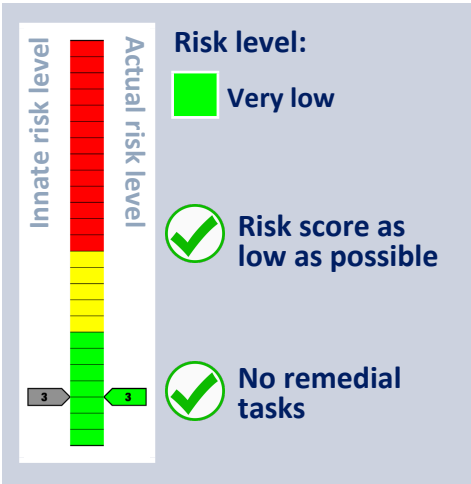
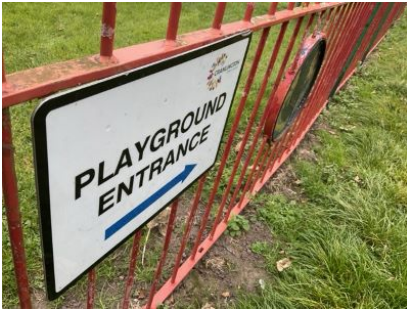
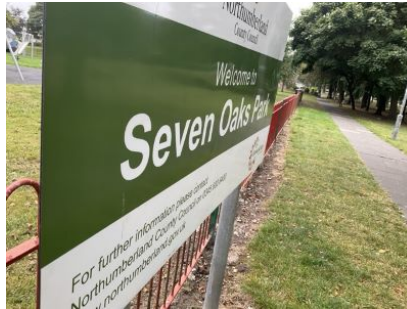
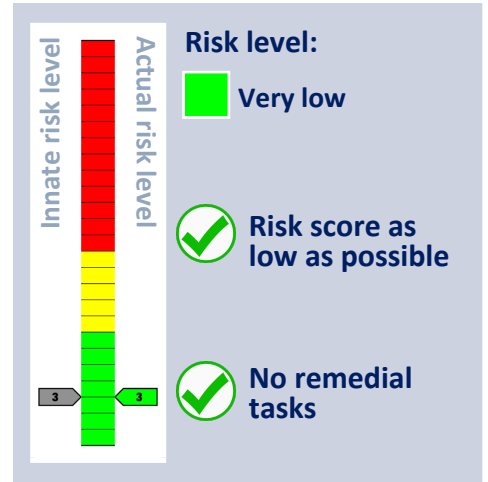
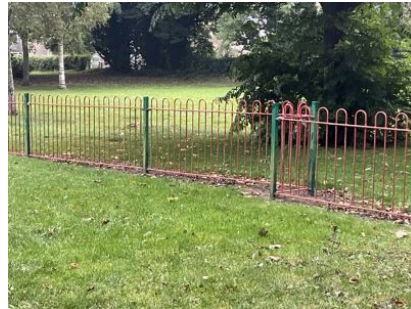
# Signage A

Minor repairs are needed.

Repair.

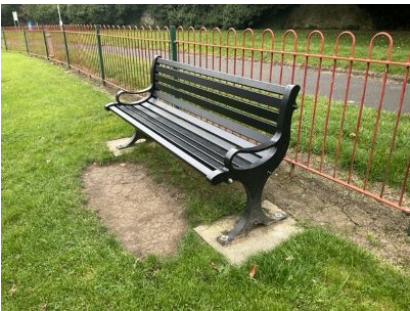
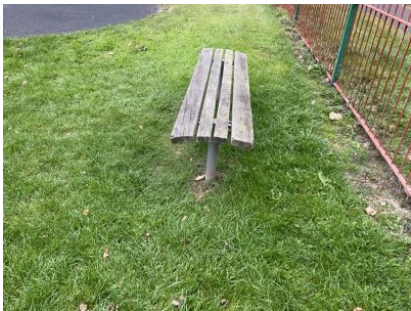
# Seating A

| Description |
|---|
| Cap missing. |

| Description |
|---|
| Replace. |

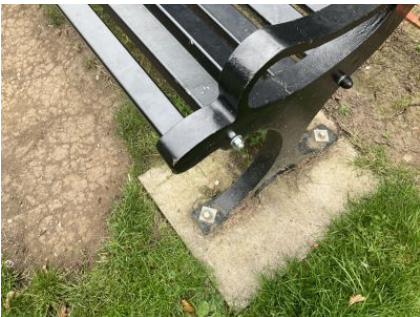
Worn ground areas.

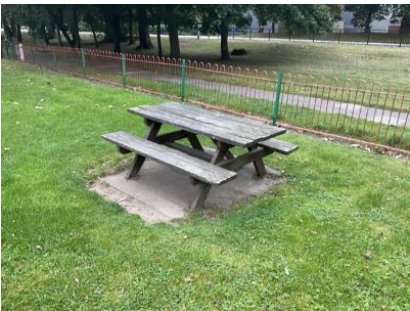
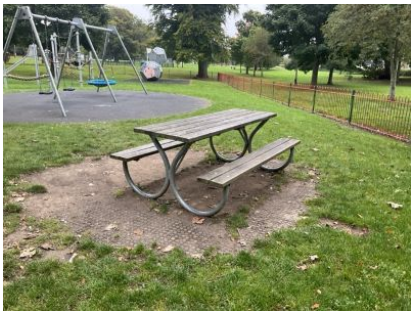
# Seating B

There is decay to timber components which may affect structural integrity. We do not recommend replacing rotten supports with timber posts which are directly set in the ground due to the increased problem of timber rot, especially in posts in contact with the ground.

Worn ground areas.

Replace decayed components where possible and plan replacement of item.  
Check on a routine basis, especially at ground or foundation level.

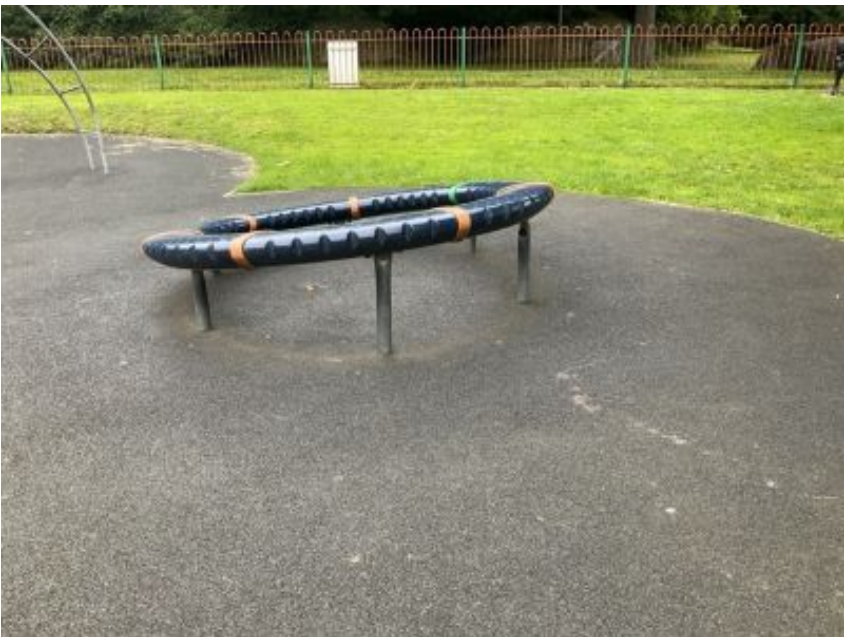
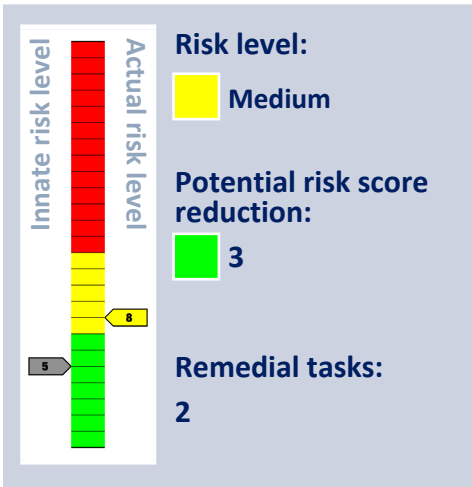
# Carousel - Supernova

Cap missing.

Shrinkage / separation of the surface. This may give a trip hazard.

Replace.

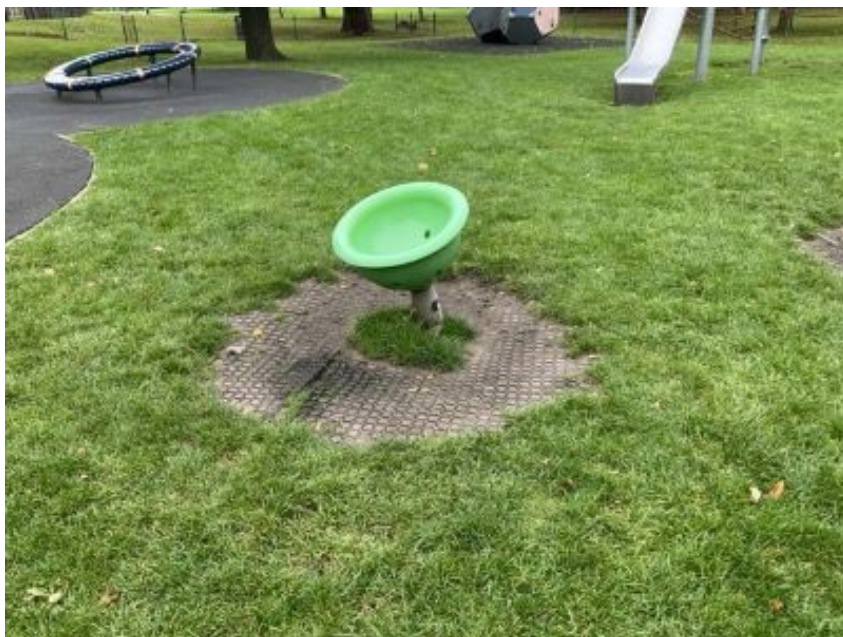
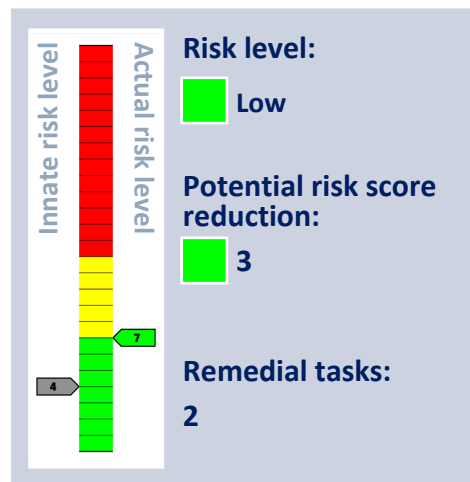
## Carousel - Bowl A

Worn ground areas.

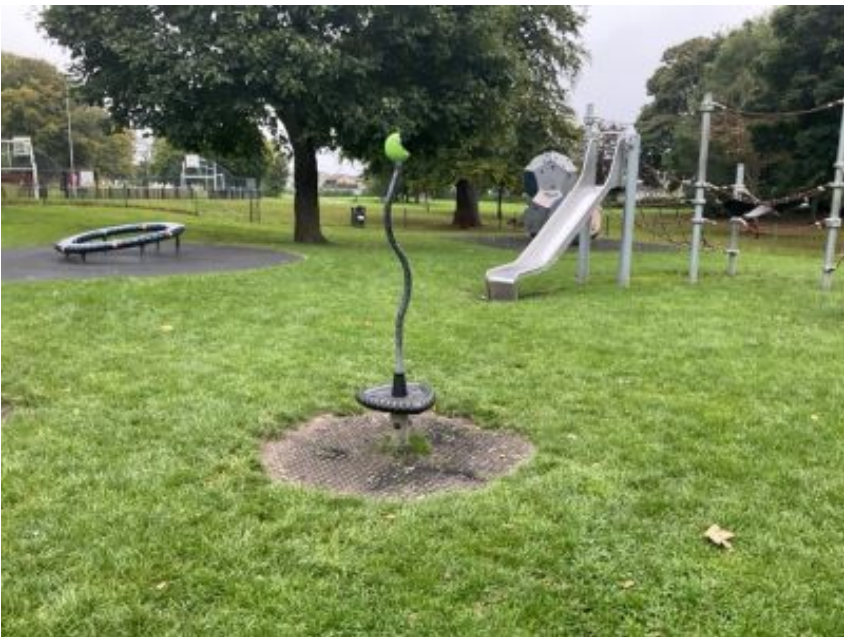
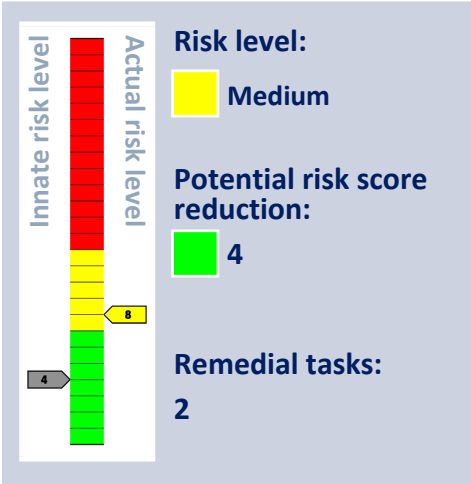
# Rotator - Platform

This equipment relies on one post for its stability. Special attention should be paid to maintenance (e.g. by monitoring degradation) and if necessary decommissioning the item before the end of its operating life.

Worn ground areas.

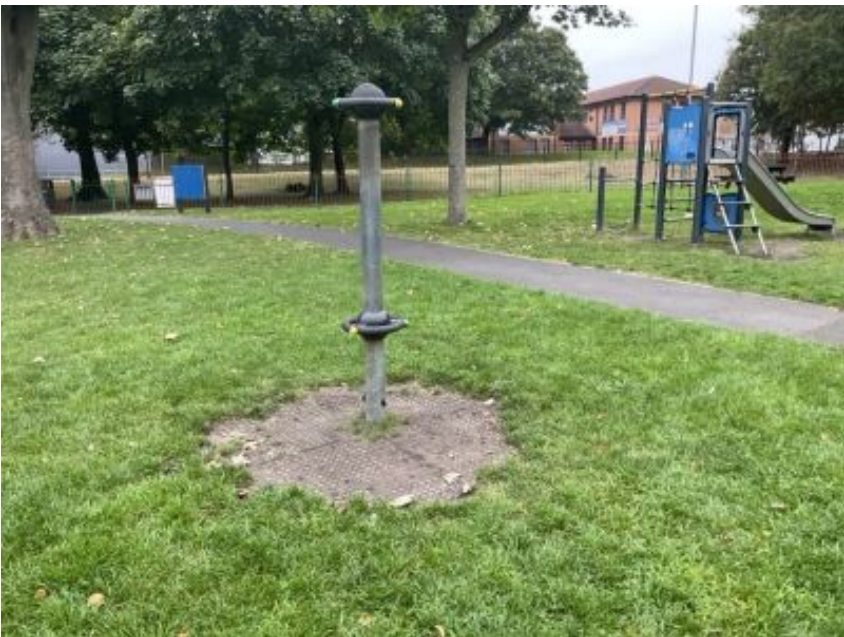
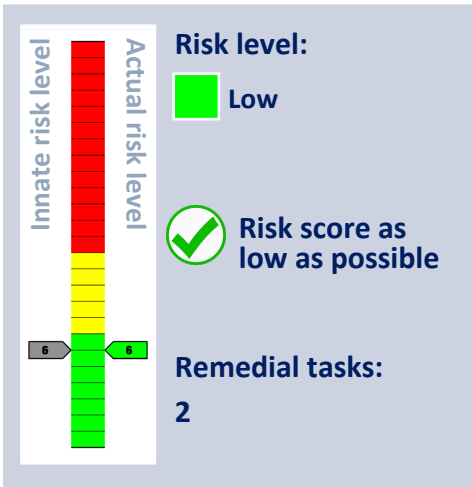
# Rotator - Pole

This equipment relies on one post for its stability. Special attention should be paid to maintenance (e.g. by monitoring degradation) and if necessary decommissioning the item before the end of its operating life.

Worn ground areas.

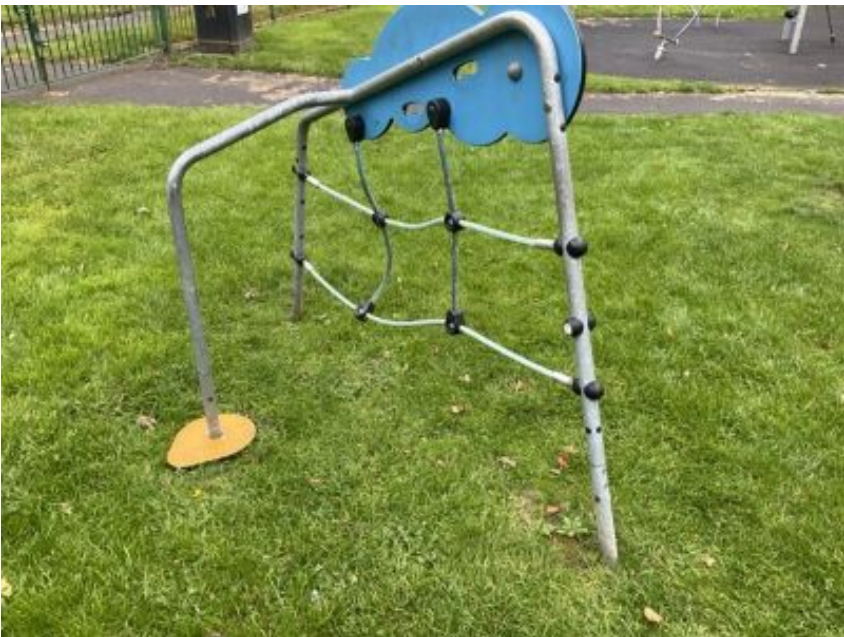
# Climber - Small

Cap missing.

Replace.

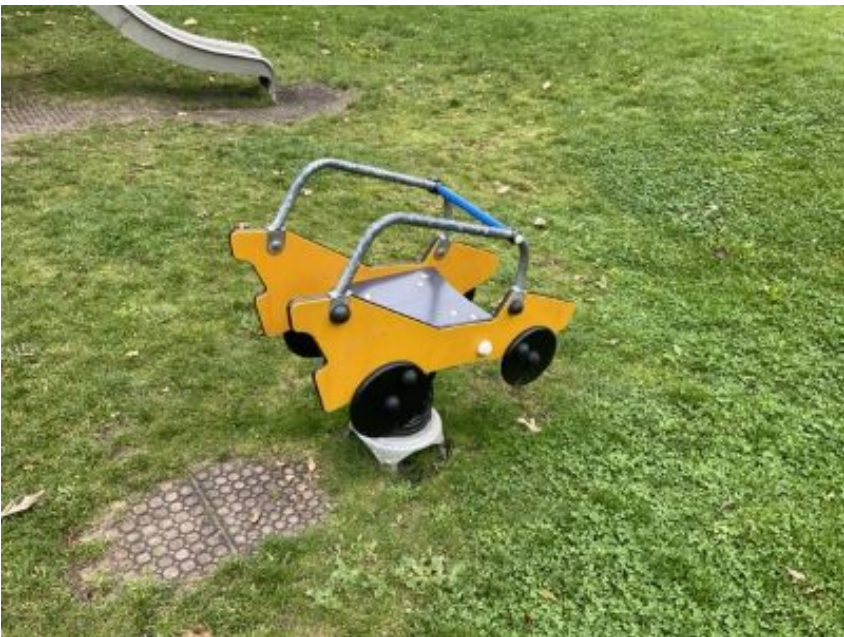
# Rocker - Car

Worn ground areas.

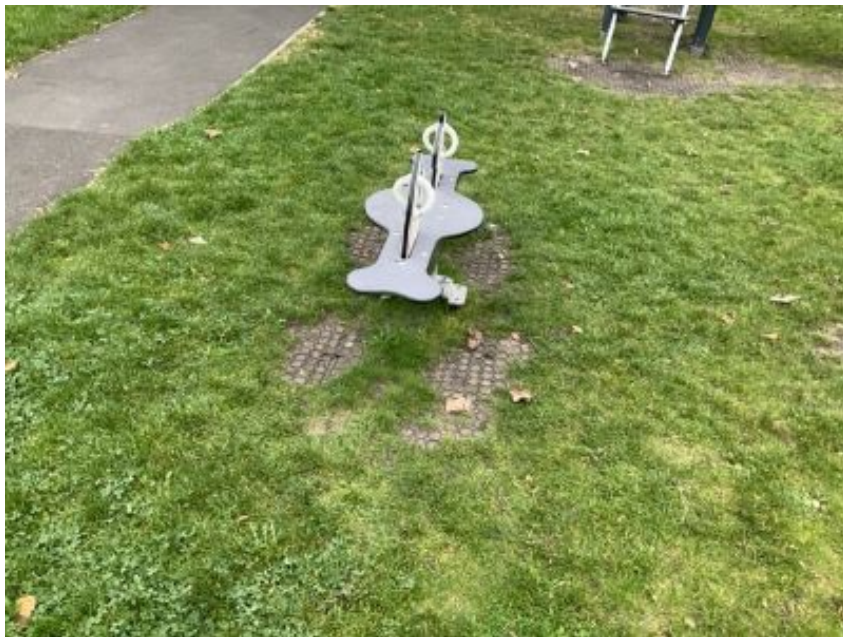
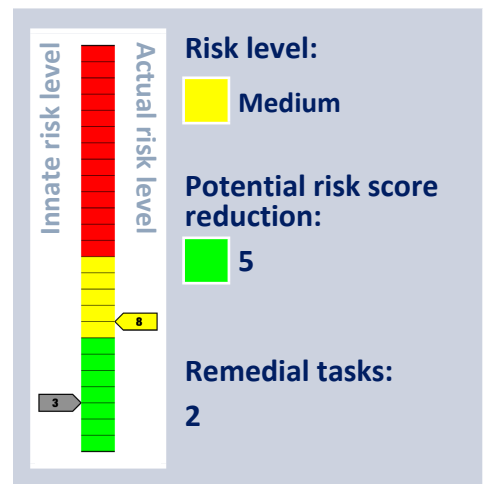
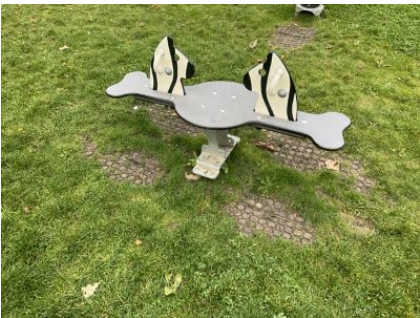
## Rocker - Seesaw - Spring

Cap missing.

Worn ground areas.

Replace.

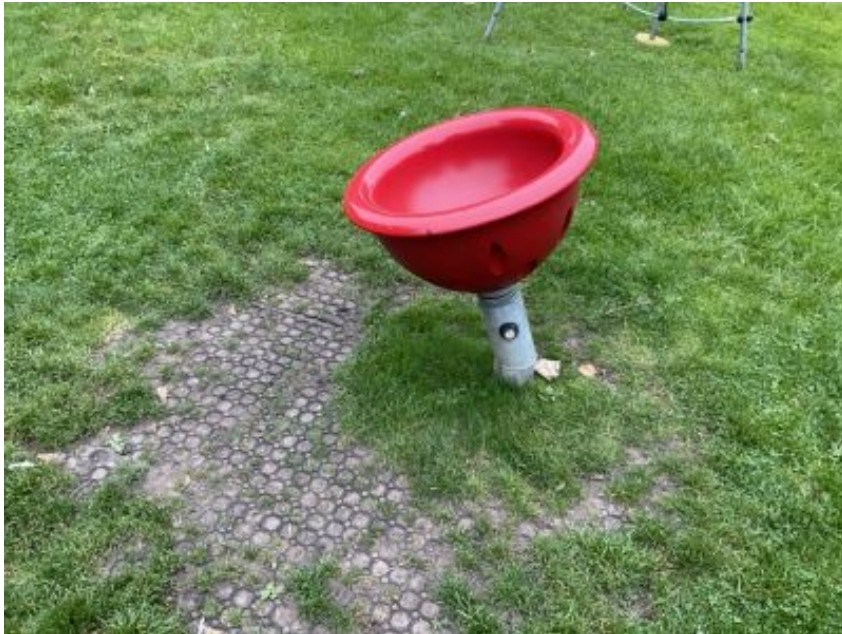
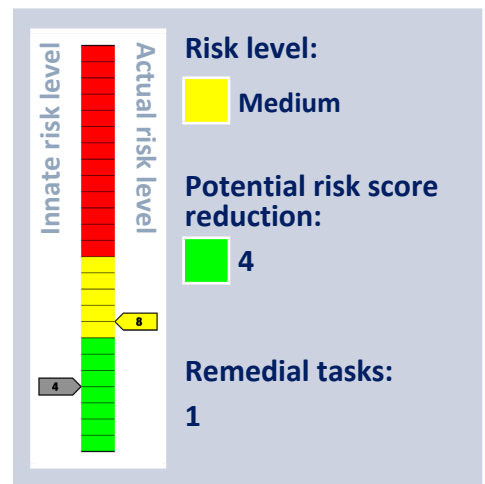
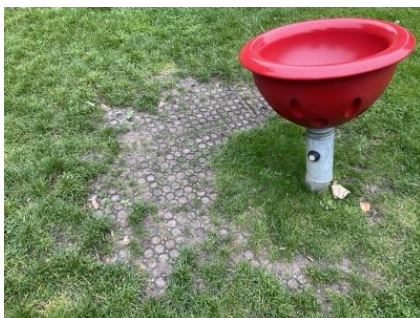
## Carousel - Bowl B

Worn ground areas.

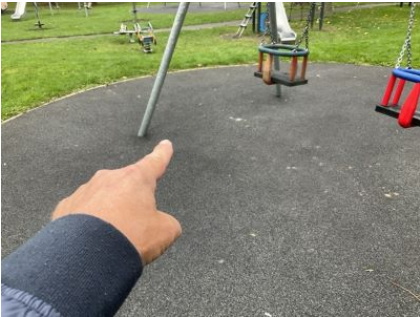
At foundations.

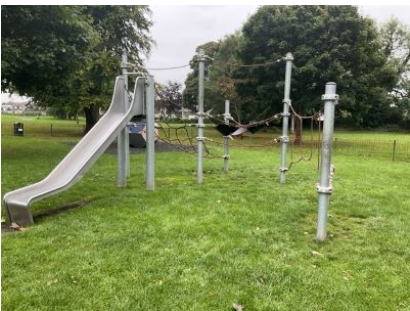
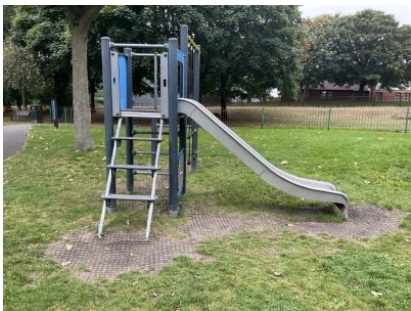
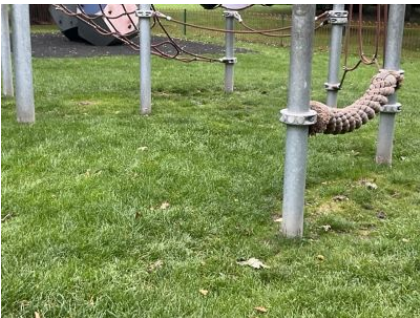
# Climber - Frame - With Ropes

This equipment relies on one post for its stability. Special attention should be paid to maintenance (e.g. by monitoring degradation) and if necessary decommissioning the item before the end of its operating life.

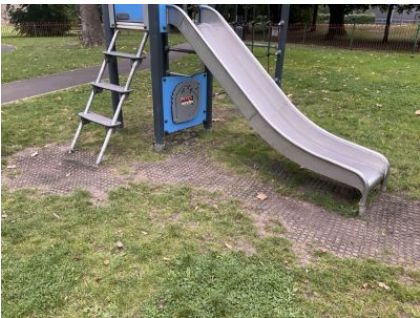
Worn ground areas.
